RR 19-20 | October 2019

SYSTEM-WIDE IMPLEMENTATION OF RAIL RIGHT-OF-WAY INCURSION TREATMENTS

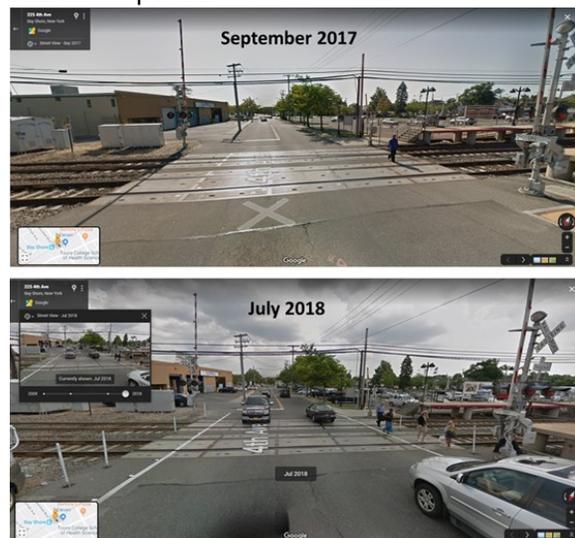
Figure 1. ROW Incursion Treatments Installed at the LIRR Crossing on 4th Ave in Bay Shore, NY (Crossing ID 338023U)

From 2016 through 2018, the Volpe Center partnered with SunRail to develop, install, and evaluate promising vehicle ROW incursion prevention engineering treatments [1]. Following this demonstration project, in early 2018 the Metropolitan Transportation Authority (MTA) Long Island Rail Road (LIRR) announced the *LIRR Forward* plan [2], which included the implementation of system-wide, high-visibility safety delineators and striping. A Google Maps before-and-after snapshot of one of these crossings is shown in [Figure 1](#) (<https://goo.gl/maps/SMdddn9PDgTFwq8R6>). The top picture shows pre-installation conditions as of September 2017, and the bottom picture shows post-installation conditions as of July 2018. Note the addition of the white edge pavement markings and reflective markers through the crossing, and flexible delineators on both sides and in-between the tracks.

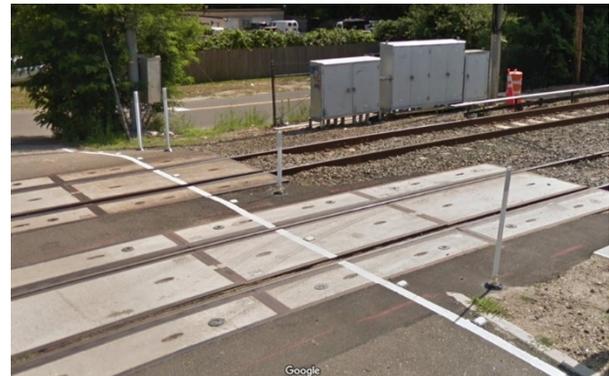
Figure 2. ROW Incursion Treatments Installed at the LIRR Crossing on Pond Road in Ronkonkoma, NY (Crossing ID 338175R)

LIRR completed the installation of the white pavement markings, reflective markers, and delineators at all of their 296 grade crossings in the summer of 2018. An example of this treatment as installed at Pond Road in Ronkonkoma, NY (Crossing ID 338175R) is shown in [Figure 2](#).
