Federal Railroad
Administration

RR 18-13 | August 2018

RAILROAD RIGHT-OF-WAY VEHICLE INCURSION PREVENTION RESEARCH

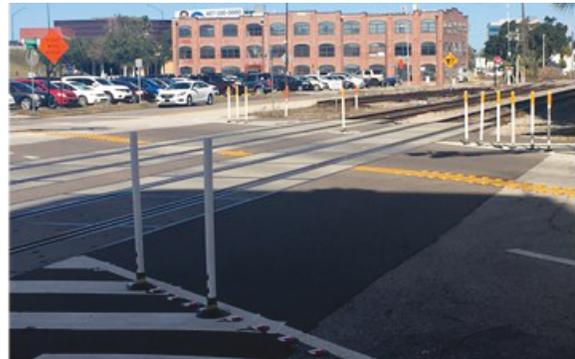
Figure 1. ROW Incursion Treatments Installed at the W. Washington St. Crossing in Orlando, FL

Treatments were installed at two crossings in the City of Orlando, FL, and evaluated through December 2016 to December 2017 after installation. The locations selected for this study were the grade crossings at W. Washington St. (Crossing ID 622188X) and W. Jefferson St. (Crossing ID 622187R) within the city. Volpe research staff developed the treatments for the two crossings. Vehicle ROW incursion data before and after the installation of the treatments was collected by SunRail and analyzed by the Volpe research staff. The ROW incursion treatments, as shown in Figure 1 for the W. Washington St. crossing, were installed on December 19–20, 2016.

The W. Jefferson St. crossing was equipped with the first two treatments (pavement markings only) and the W. Washington St. crossing was equipped with all four treatments. This was done to determine if the addition of reflective markers and delineators provided added safety. The treatments installed at the W. Washington St. crossing were shown previously in Figure 1. Figure 3 shows the pavement marking treatments installed at the W. Jefferson St. crossing.

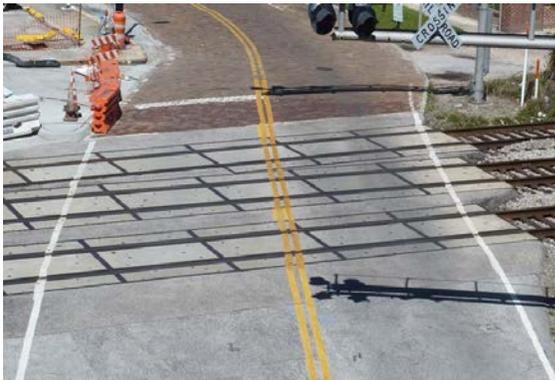
Figure 3. ROW Incursion Treatments Installed at the W. Jefferson St. Crossing
